- Introduction to the case study
- Tools and technologies
  - Experimental Testing
  - Numerical Simulation
- Main points

A Resilient Future: Science and Technology for Disaster Risk Reduction

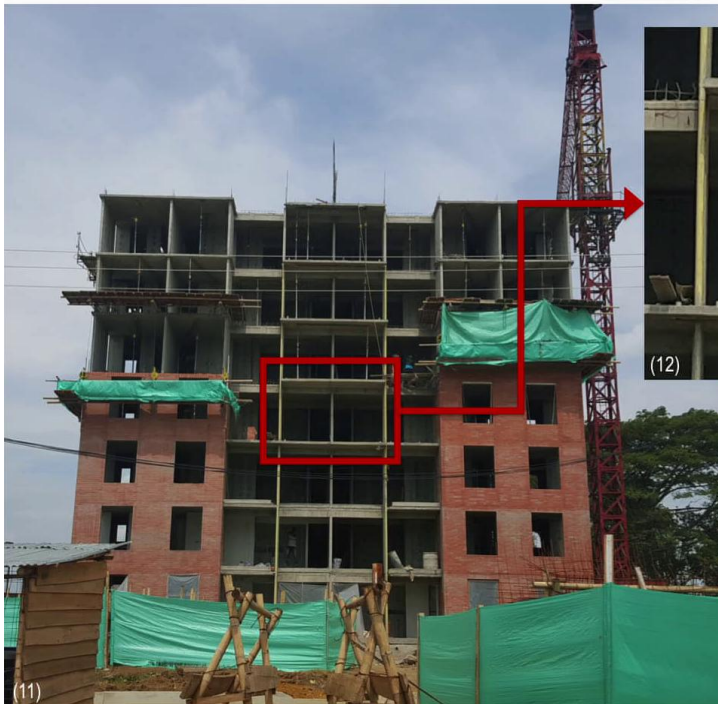
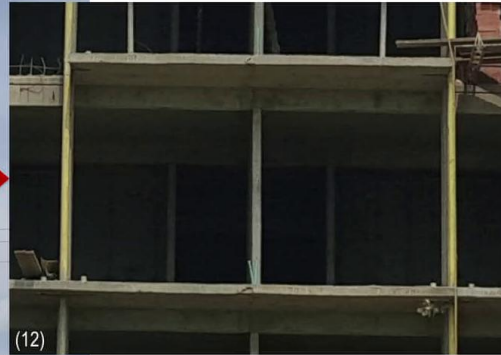
Although major cities are fortunately located in regions of low to medium seismic hazard, almost 40% of the population lives in areas of high seismicity. In these areas, the building code requires engineers to design the structures such that they can resist to horizontal forces equal to half of their own total weight. This is the case of the city of Cali, the third largest in Colombia, from where the next photos were taken. Over the last 10 to 15 years the increasing demand of housing for low income population in Colombia associated to the significant increase of cost of land has prompted construction companies to massively build medium to high rise reinforced concrete wall buildings. These structures are made of concrete and reinforcing steel and require a relatively non-specialized and cheap labor. Comparatively, the cost of materials is high and has pushed to the development and application of construction techniques that minimize its use. It is therefore not surprising that most of these new residential buildings have been constructed with walls that have thicknesses as low as 80 millimeters. Besides, there are typically only lightly reinforced often with just a single layer of steel rebars instead of the more common two rebar configuration.

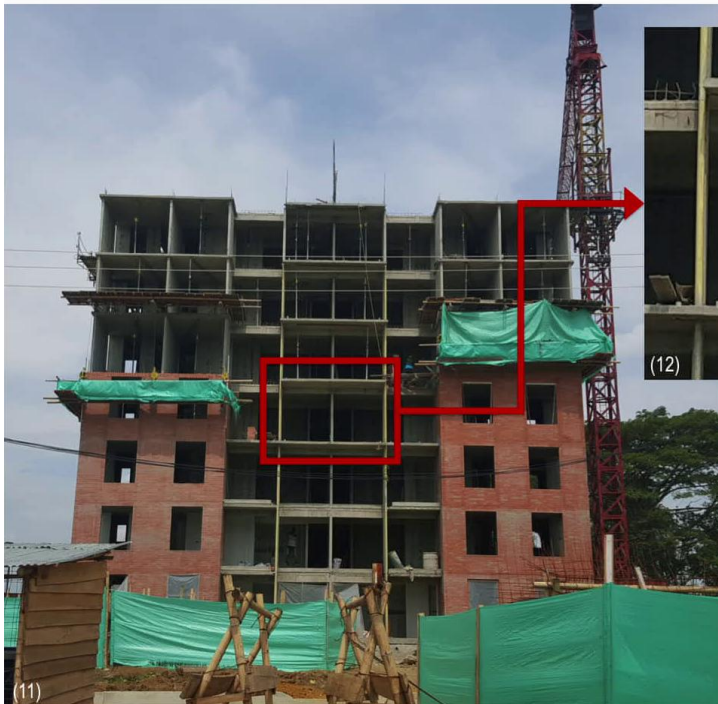
- Residential buildings constructed with very thin walls and only one layer of reinforcement
- Very large ratios  $h / b \Rightarrow$  Out-of-plane instability under seismic loading?

The end result are walls with very large ratios between their height and their thickness raising concerns regarding the possible development of instability when the earthquake strikes. That is, to say seismic loading.

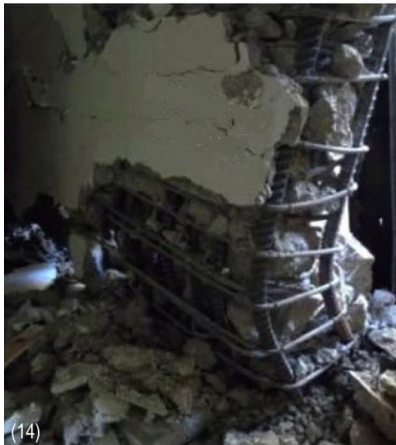
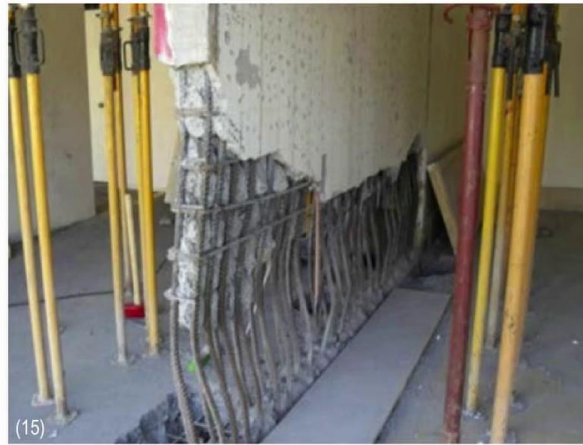
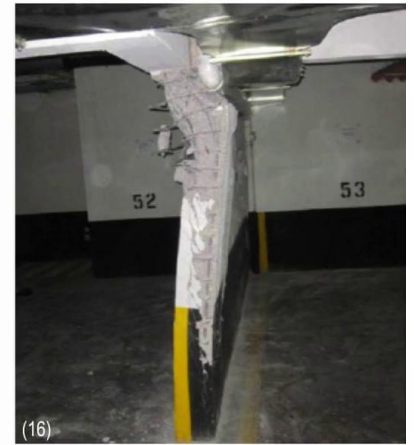
It is a bit like holding a playing card in between your fingers and compressing it. Since the card is quite thin and very elongated, it will buckle or bend in direction perpendicular to it's own plane. Something similar can happen with thin reinforced concrete walls but we will see more about it soon. This failure mode was observed in the recent earthquakes of Chile in 2010 and of New Zealand in 2011, which caused significant damage to some modern reinforced concrete walls. These pictures show examples of buckled structural walls after the ground shaking suggesting stability problems.
